Navajo Abandoned Uranium Mine

Site Screen Report

Chester Mud No. 1 AUM Site

August 2010

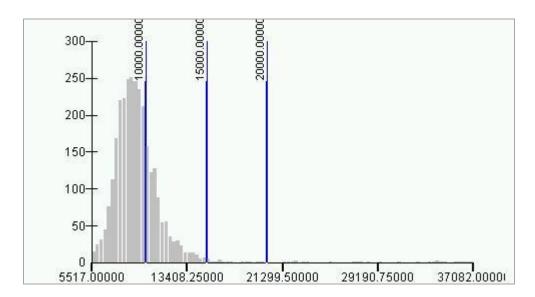
Distribution Chart and Statistics:

The following chart and statistics were generated by ESRI ArcGIS 9.3.1, and show the general distribution of the site gamma radiation measurements. The horizontal X axis represents the gamma radiation reading levels in cpm (lowest levels to the left). The vertical Y axis represents the frequency of each gamma radiation level.

Count:
 2969

Minimum:
 5517.00000

Maximum:
 37082.00000

Mean:
 9476.90232

Median:
 9070.00000

Standard Deviation:
 2768.58616

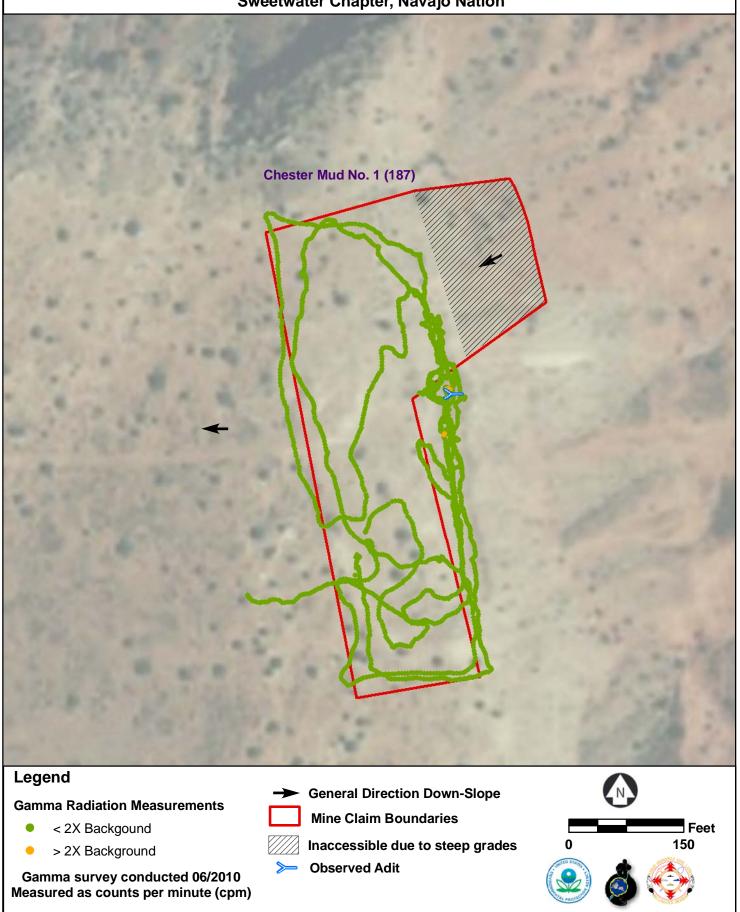
Photo 1. Chester Mud No. 1 Mine Site

1 adit, sealed with rock and foam

Waste rock scattered throughout site

Sealed adit; scattered unreclaimed waste rock

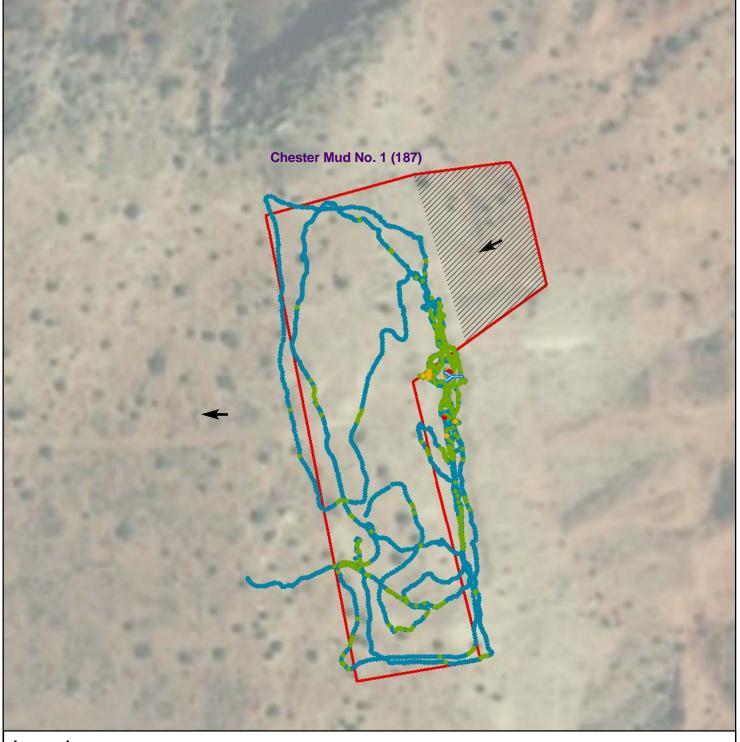
Figure 2 - Gamma Radiation Measurements Chester Mud No. 1 (187) Sweetwater Chapter, Navajo Nation

A total of 2,969 gamma radiation measurements were collected from the mine site, ranging from 5,517 cpm to 37,082 cpm. Measurements collected in the vicinity of the adit were found at levels up to approximately 30,000 cpm. The measurements are represented in Figures 1 and 2.

Observed Adit
